San Benito County Juvenile Hall: 2007-08 Annual Review

**Conducted by
Law and Justice Committee**

Issued July 31, 2008

**County of San Benito
Civil Grand Jury
2007-2008**

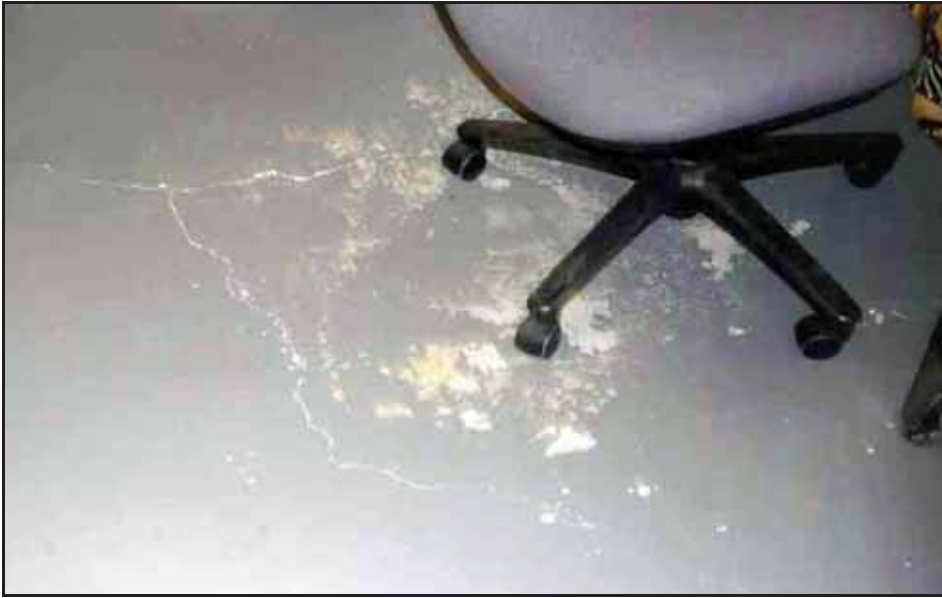
Figure 1 Example of Poorly Maintained Concrete Flooring

- Carpets are stained.
- Concrete floors are cracked and stained (see Figure 1).
- Walls are dirty.
- Mold spots are visible on the ceiling.
- Holes and dirt from a former wall phone are visible on a wall in the lobby (see Figure 2).

This floor is in the nurse's room. Note the cracked and pitted surface.

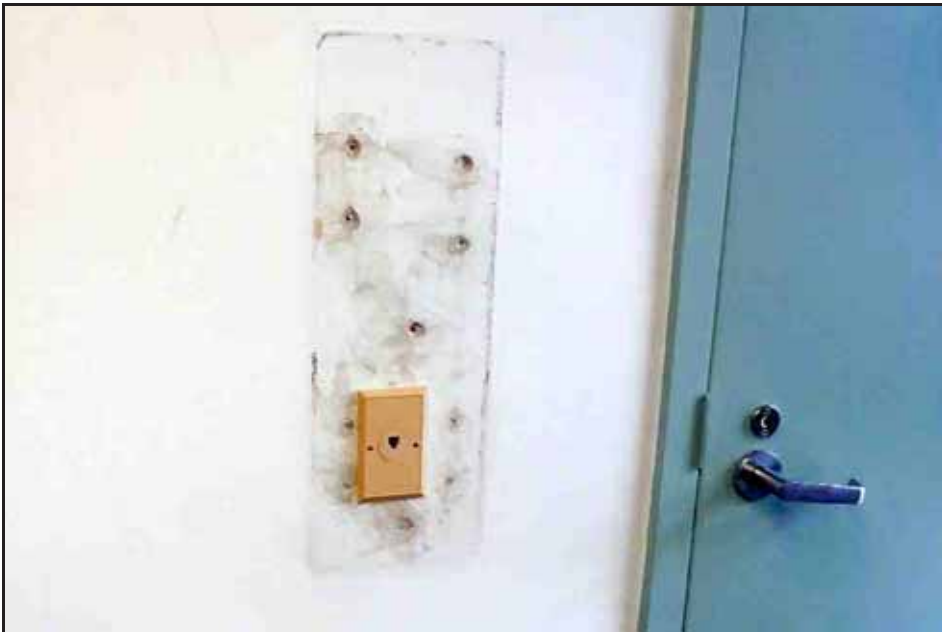
Figure 2 Former Payphone Location in Lobby

Note the wall has not been repaired or painted.

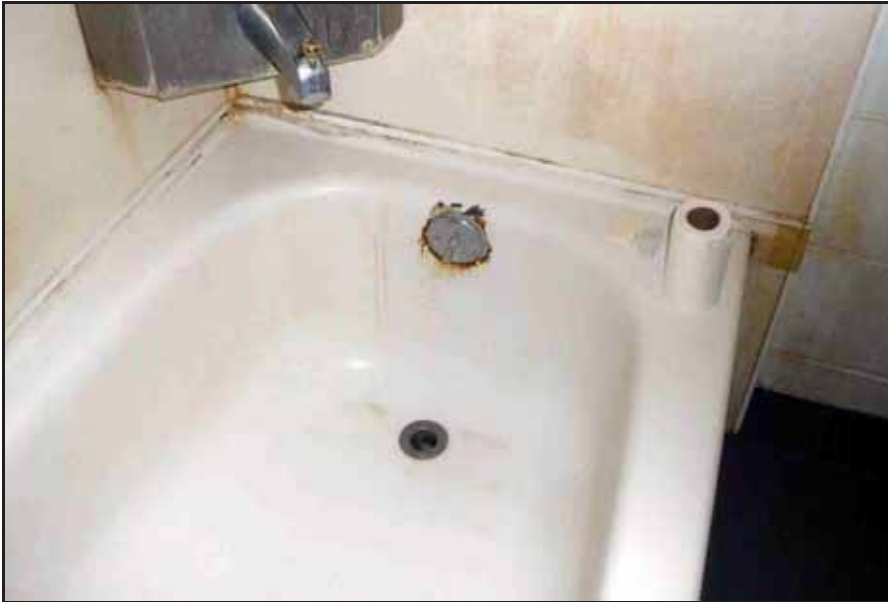
Figure 3 Intake Bathroom Detail: Bathtub

- Shower stalls and the bathroom tub (which is used during the intake process) have visible mold and/or rust (see Figures 3 and 4).
- Some drain traps are broken and/or painted over (see Figures 5 and 6).

This detail shows part of the tub that wards use during the intake process. Note the rust, mold, and corrosion at the seams and around the spigot and metal parts. The bathtub has no safety bar or non-slip surface.

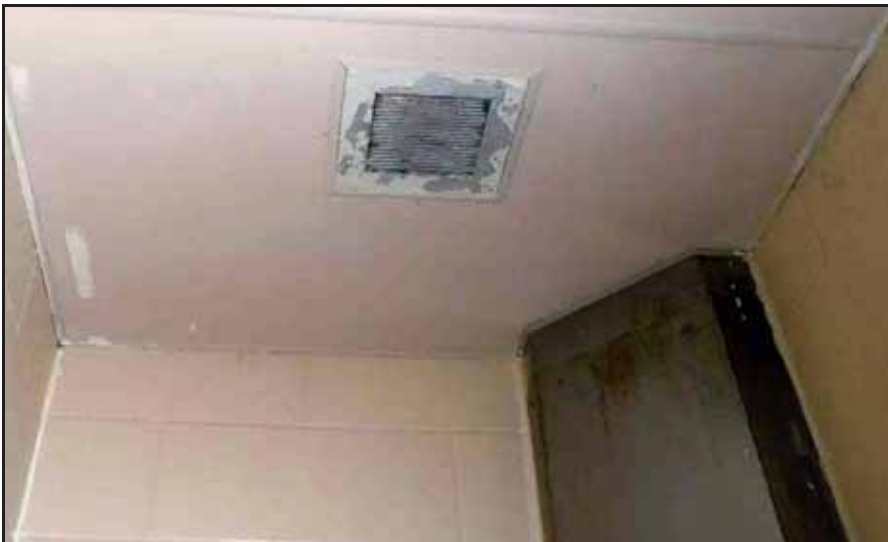
Figure 4 Intake Bathroom Detail: Shower Stall Ceiling

This detail shows the air vent. Note the rust, dirt, and corrosion on the air vent and the stall surfaces.

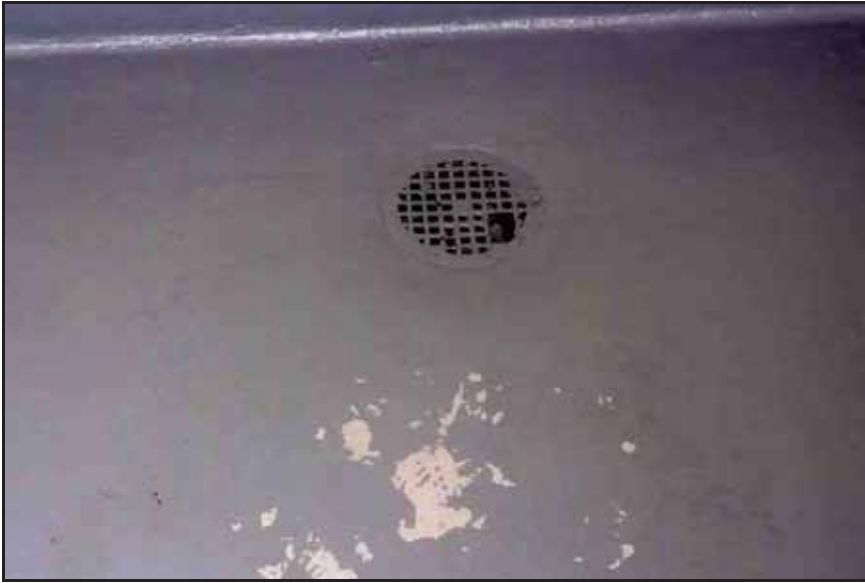
Figure 5 Shower Stall Drain and Floor

The painted floor is peeling, which allows contaminants to accumulate, and so, causes a health hazard. The drain is broken and jagged, which is a safety hazard.

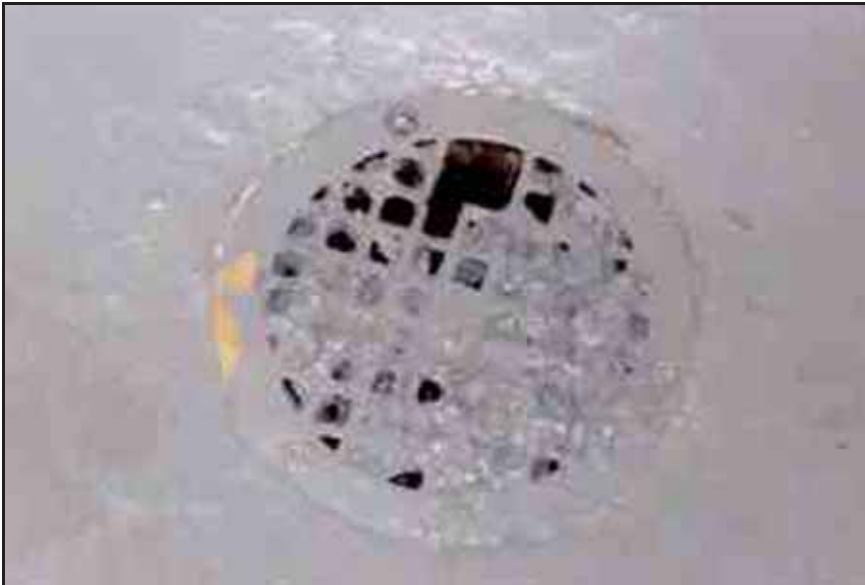
Figure 6 Close-up of a Shower Drain

Note the clogged screen that impedes drainage: a sanitation hazard. The screen is jagged and broken, a safety hazard to bare feet.

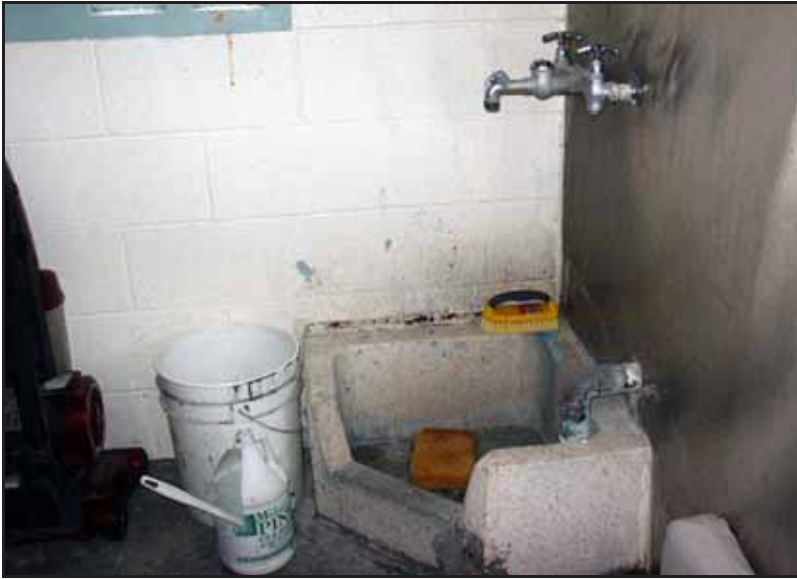
Figure 7 Sink in the Laundry Room

- The sink/shower in the laundry room is filthy (see Figures 7).
- Electrical wiring is exposed on the floor in the dayroom where the wards eat, do activities, and spend time outside of their cells (see Figures 8).

Note the filthy basin and the dirty wall and pipe in this photo of the laundry room, which is a small room. Across the room from this sink, blankets, towels, and drinking water are kept on open shelves (see also Figure 14).

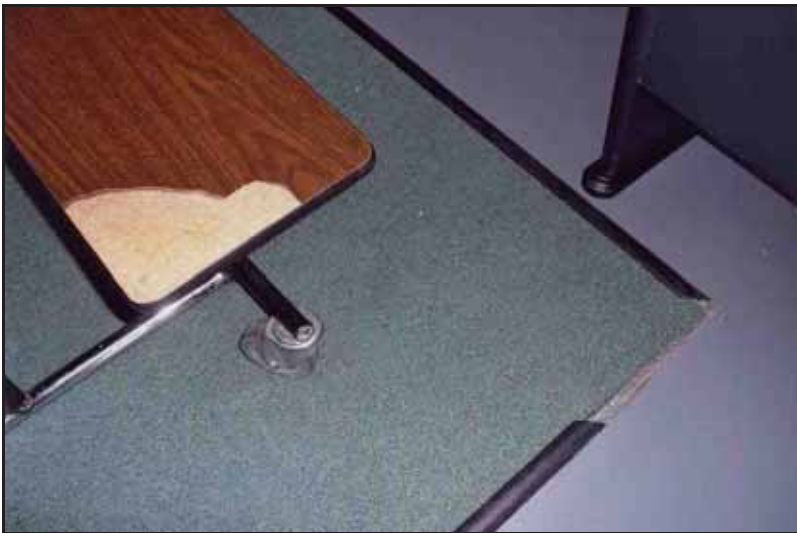
Figure 8 Detail of Carpet and Seating in Day Room

- Formica tops on some benches in the day room are broken (see Figures 8).
- Upholstered chair seats in the courtroom are stained.
- Part of the trim on the intake desk is missing.

Note the broken covering on the bench that is connected to a table at which the wards sit. Also, note the unfinished edge of the carpet. Some Grand Jury members observed exposed wiring along that carpet edge.

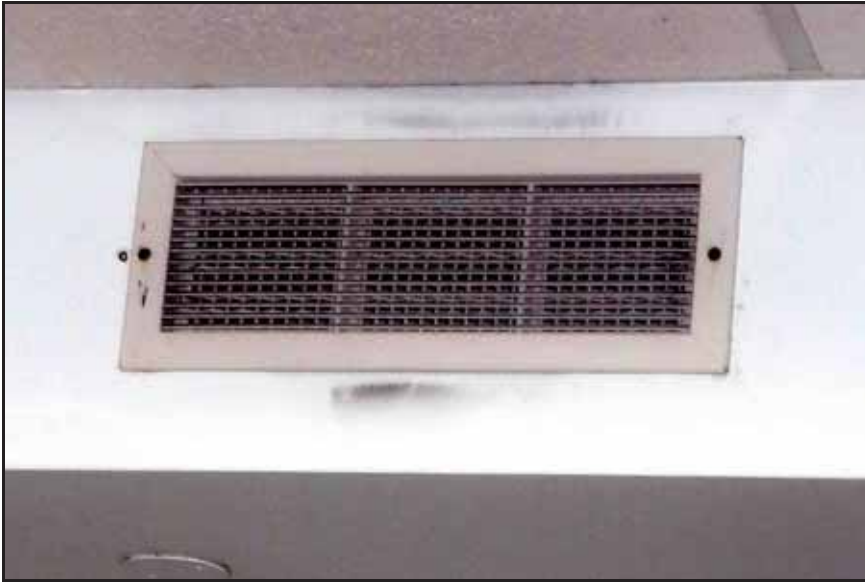
Figure 9 Typical Air Vent (from Courtroom)

- Air vents in the ceiling and walls look filthy (see Figures 9).
- Lighting wires are exposed and hanging in the storage closet next to the courtroom.
- There is a gap in the seam of a wall in the storage closet next to the courtroom.

During the December visit, the smell of a nearby controlled burn was evident indoors. Soot was visible in and around air vents (see Figure 9). Staff stated that when fires or controlled burns occur in the area, the smell does get inside the building. Wards have complained about the smells. Staff could not recall the last time the air filters had been changed.

Note the soot around the vent. Several air vents throughout the building displayed visible signs of such dirt.

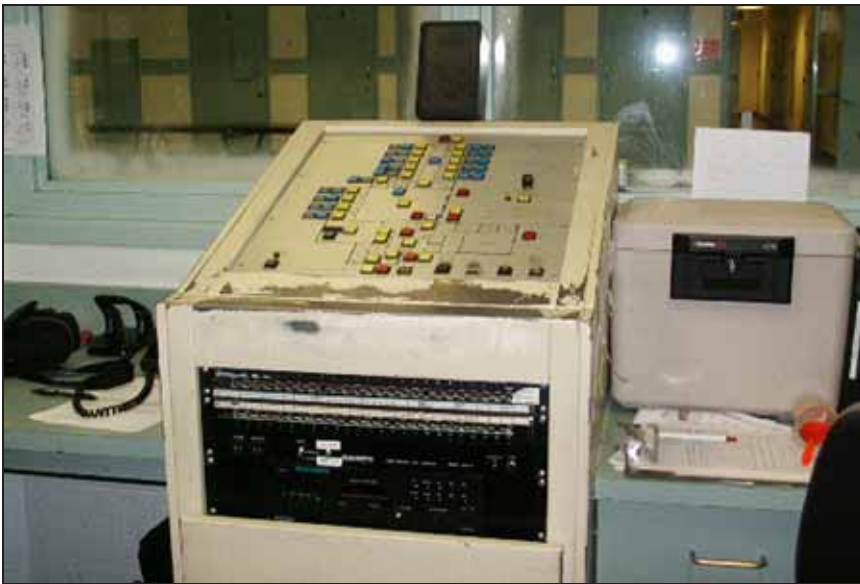
Figure 10 Security Control Panel

Juvenile Hall still uses and maintains the original security control panel that was installed in 1992 (see Figure 10). The current budget includes funds to purchase a new control panel. However, the Juvenile Hall staff is unsure when the new system will be purchased and installed.

- F12.** Juvenile Hall's security control panel is out-of-date.
- F13.** The bathtub and shower stalls are unsafe in that they have slippery or corroded surfaces.

This photo shows the antiquated security control panel (center of photo) that the Juvenile Hall operates in its control room. Juvenile Hall installed this equipment in 1992 when the facility was built.

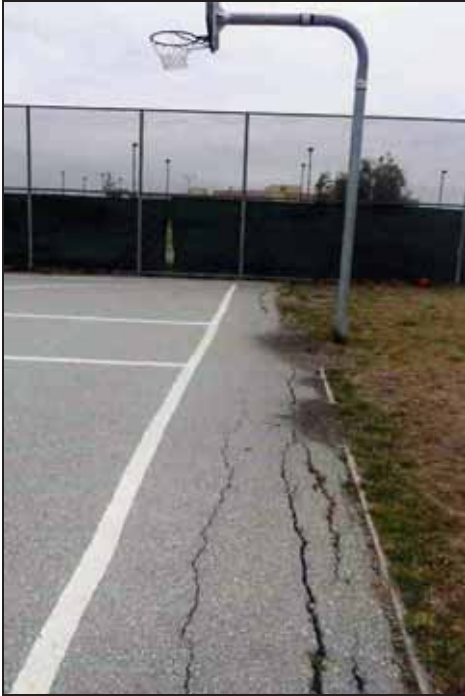
Figure 11 Typical Asphalt Condition in Courtyard

The courtyard, which the wards use for basketball and other recreational games, is part blacktop and part lawn. During both the October and December tours, Grand Jury members observed that the blacktop had long cracks alongside the grassy area; the lawn had dry patches and holes; and weeds were sprouting out of cracks next to the wall (see Figure 11).

Note the long and widening cracks in the blacktop. In some parts (not visible), weeds are sprouting. Also, note the poorly maintained lawn.
Source: Grand Jury member photo, December 2007 Juvenile Hall visit.

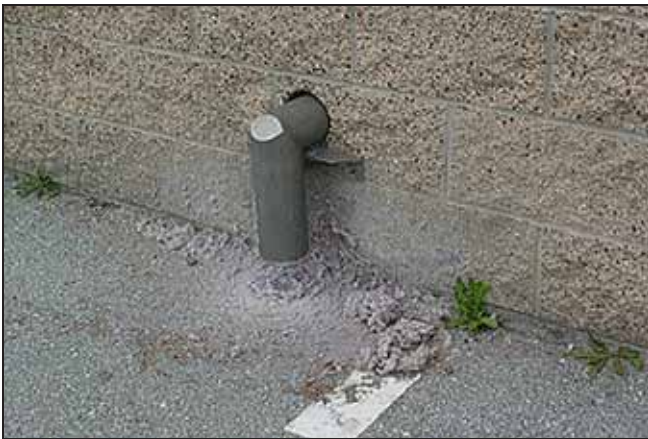
Figure 12 Laundry Room Vent Area

- Lint from the laundry room lay on the ground next to the wall (see Figure 12).
- Exterior doors, metal posts, and drain spouts show signs of corrosion.
- Copper pipes in the boiler room are leaking and/or show corrosion.
- A part of the inner wall (insulation and pipes) in the boiler room has a hole in it.
- Numerous piles of rodent fecal droppings lay in the boiler room.

Note the build-up of lint alongside the wall that faces the courtyard, which the wards use for recreational purposes. Grand Jury members also observed weeds sprouting alongside the seams of the outside walls in the courtyard.
Source: Grand Jury member photo, December 2007 Juvenile Hall visit.

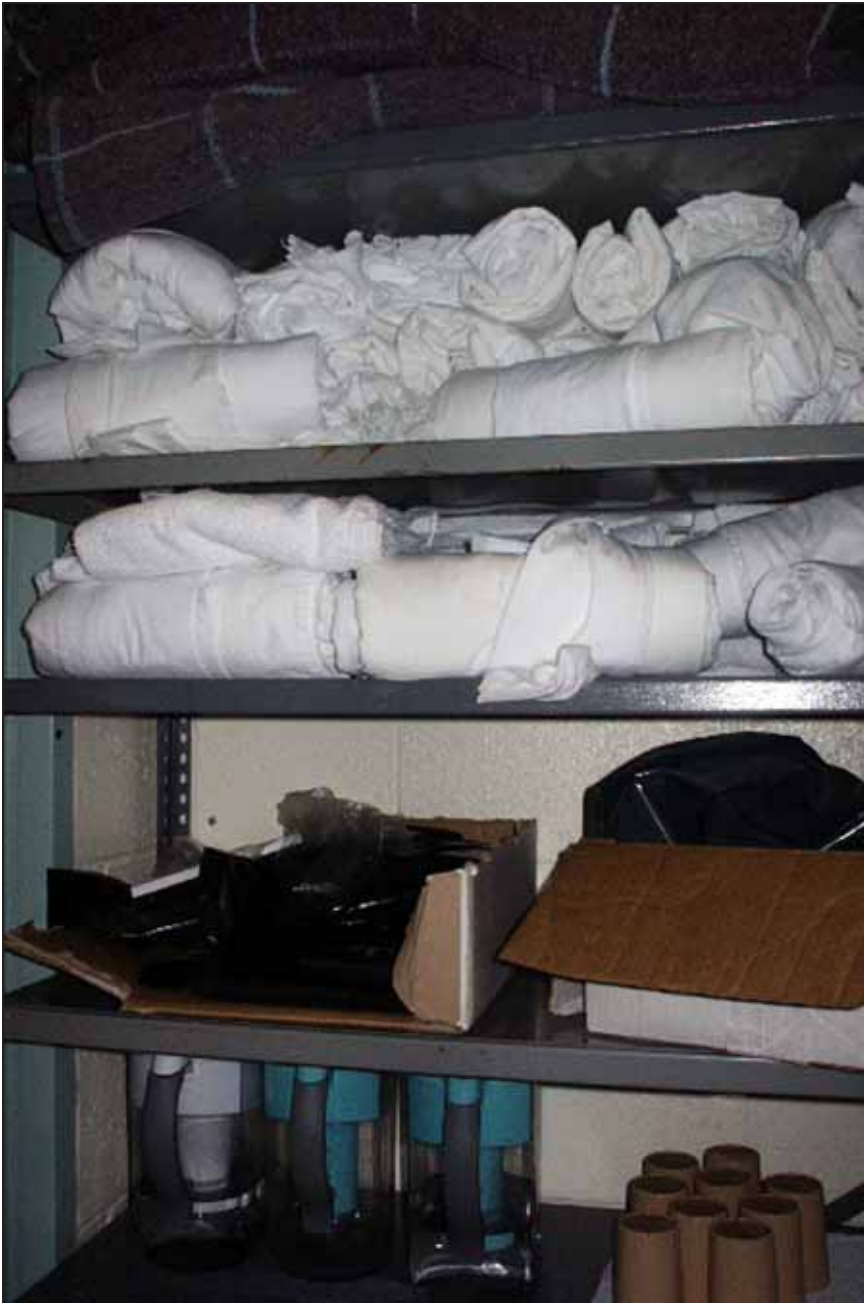
Figure 14 Storage Space in Laundry Room

These open shelves line part of the west wall of a small laundry room. Note the untidiness of the blankets on the top shelf and the laundered towels on the next two shelves. These clean blankets and towels are kept in the open in the same room as the sink that is used for cleaning purposes (see Figure 7). The fourth shelf holds pitchers of drinking water and cups. Right beneath this shelf is a pile of used slippers.

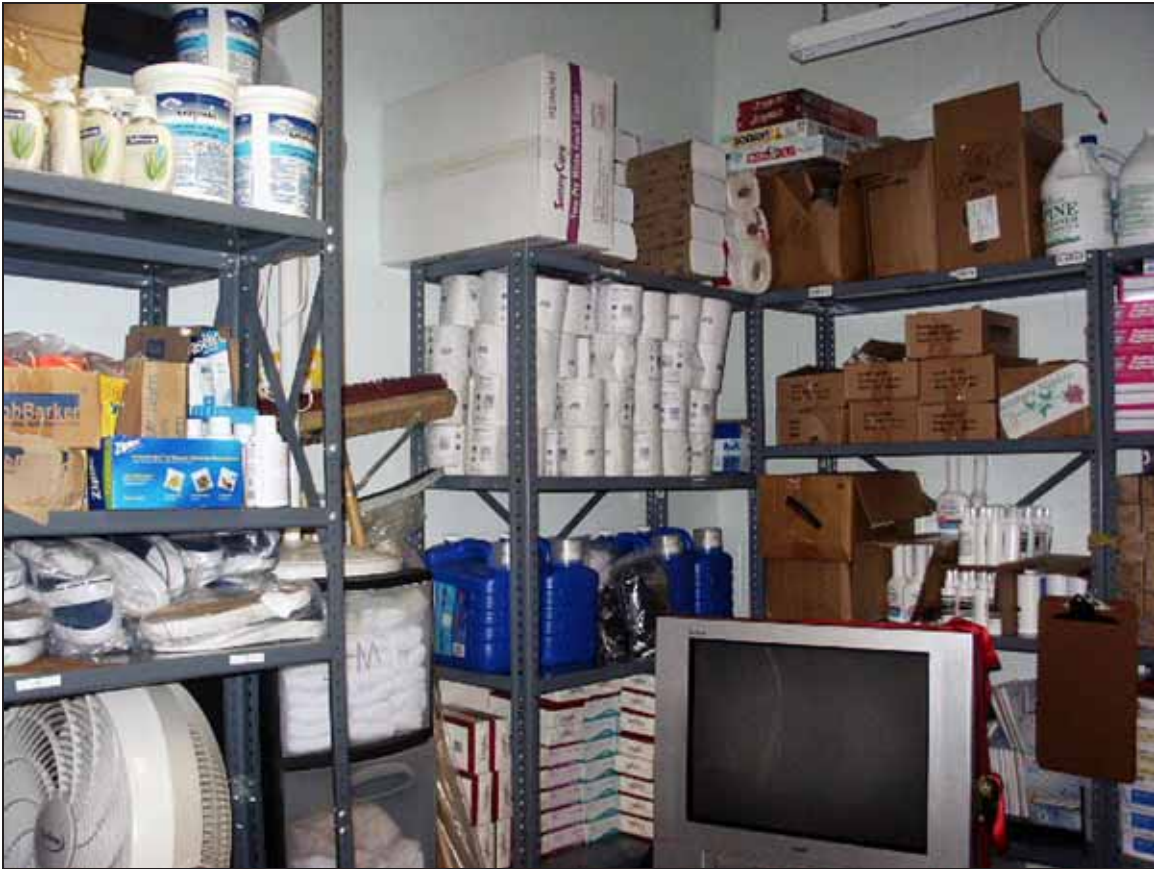
Figure 15 Storage Room next to Courtroom

This photo shows half of the largest storage room for the Juvenile Hall. Various types of items are stored here, such as cleaning materials, laundry materials, toiletries and clothing for the wards, bathroom articles, napkins and paper towels, reams of paper, and board games.

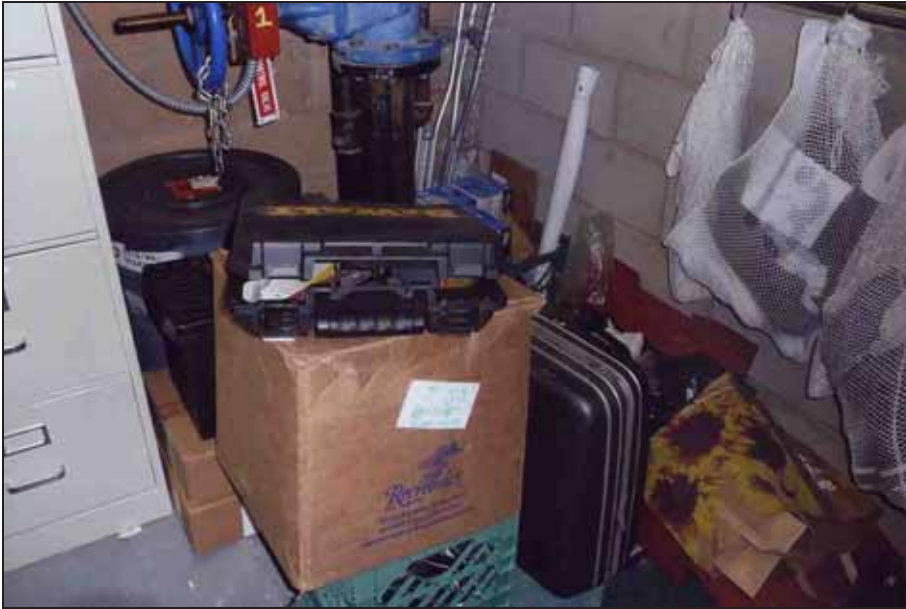
Figure 16 Storage Closet next to the Multi-Purpose Room

Juvenile Hall stores various items in this small storage space, including the personal items of wards while they are detained at the facility. The white bags hanging from the wall hold wards' clothing and other items.

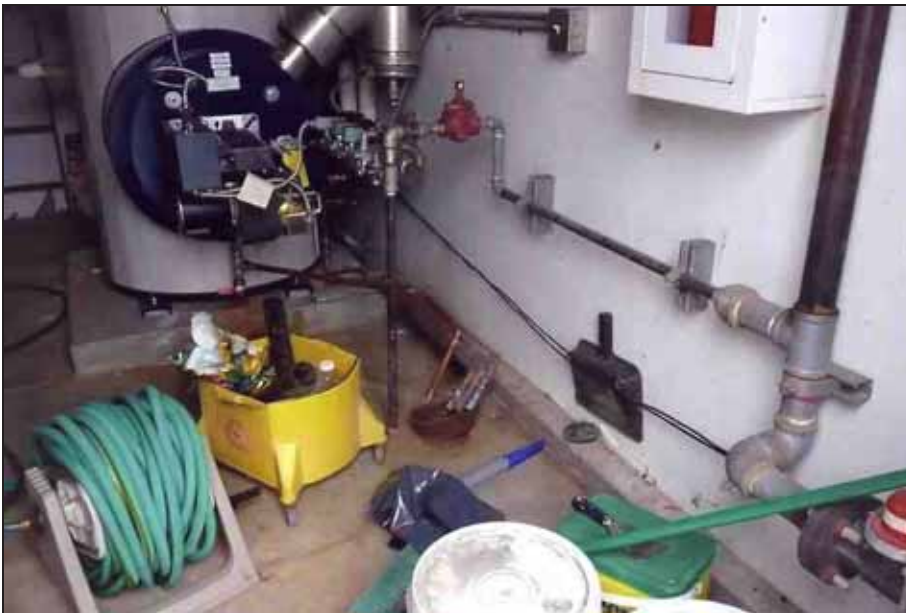
Figure 17 Storage in Boiler Room

This picture shows the boiler room that is cluttered and unorganized.

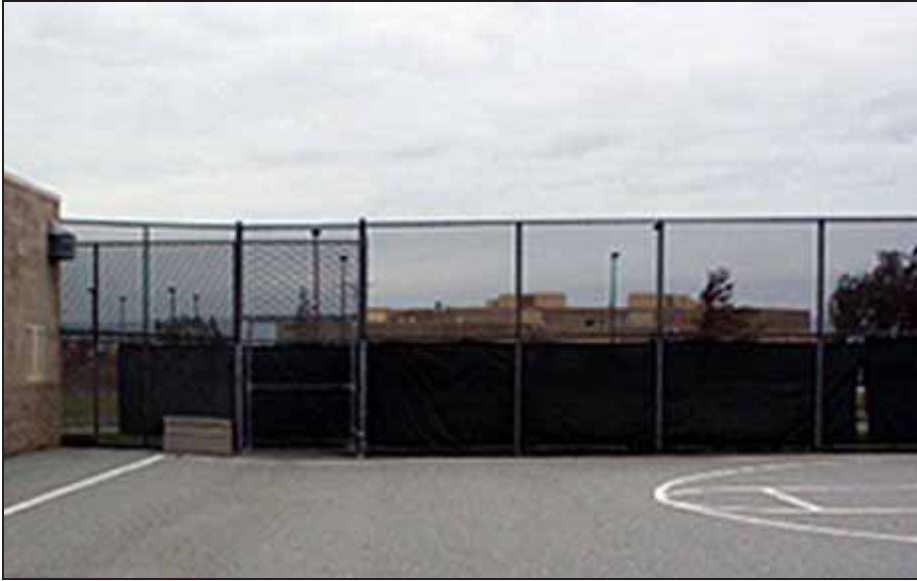
Figure 18 Back Security Fence (North side facing the County Jail)

Grand Jury members observed that the tarp has gaping holes in several places. The tarp also does not completely cover the fence on the northwest side of the courtyard (See Figures 18 and 19).

- F14.** The single fence structure, with green tarp covering, is inadequate for the proper security and safety of young wards.
- F15.** Juvenile Hall has no emergency generator for back-up power.

The green tarp, which was installed as a safety measure, does not completely shield the courtyard from view. Note where the green tarp ends. Also, note the gap in the fence at the right.

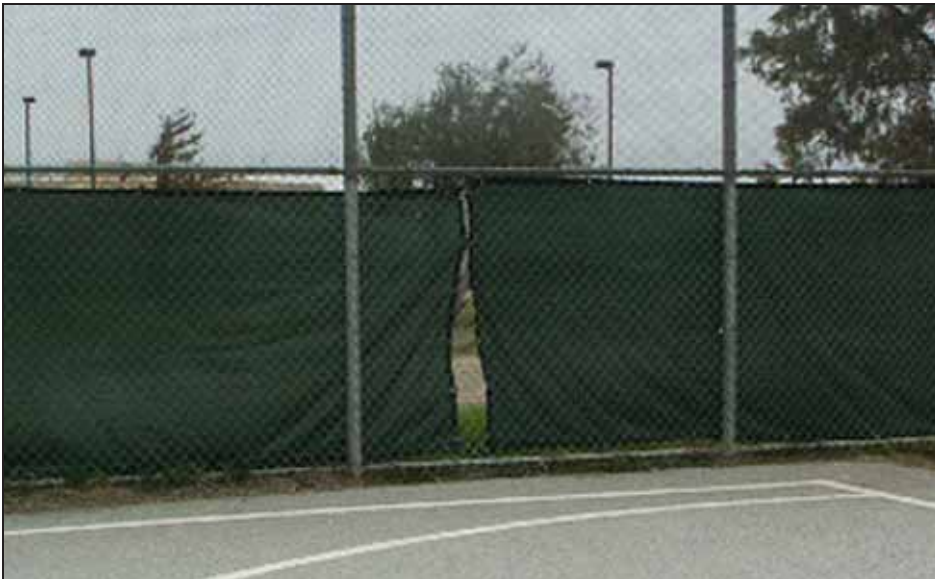
Figure 19 Close-up of Gap in Security Fence

This is a close-up of one of the several gaps in the green tarp.
