Biological Sciences – Inventory, Permitting, and Planning

Subject: Evaluation of 40 Pools Identified on Panoche Valley Solar Footprint

Panoche Valley Solar Project

**EPHEMERAL POOLS
OVERVIEW**

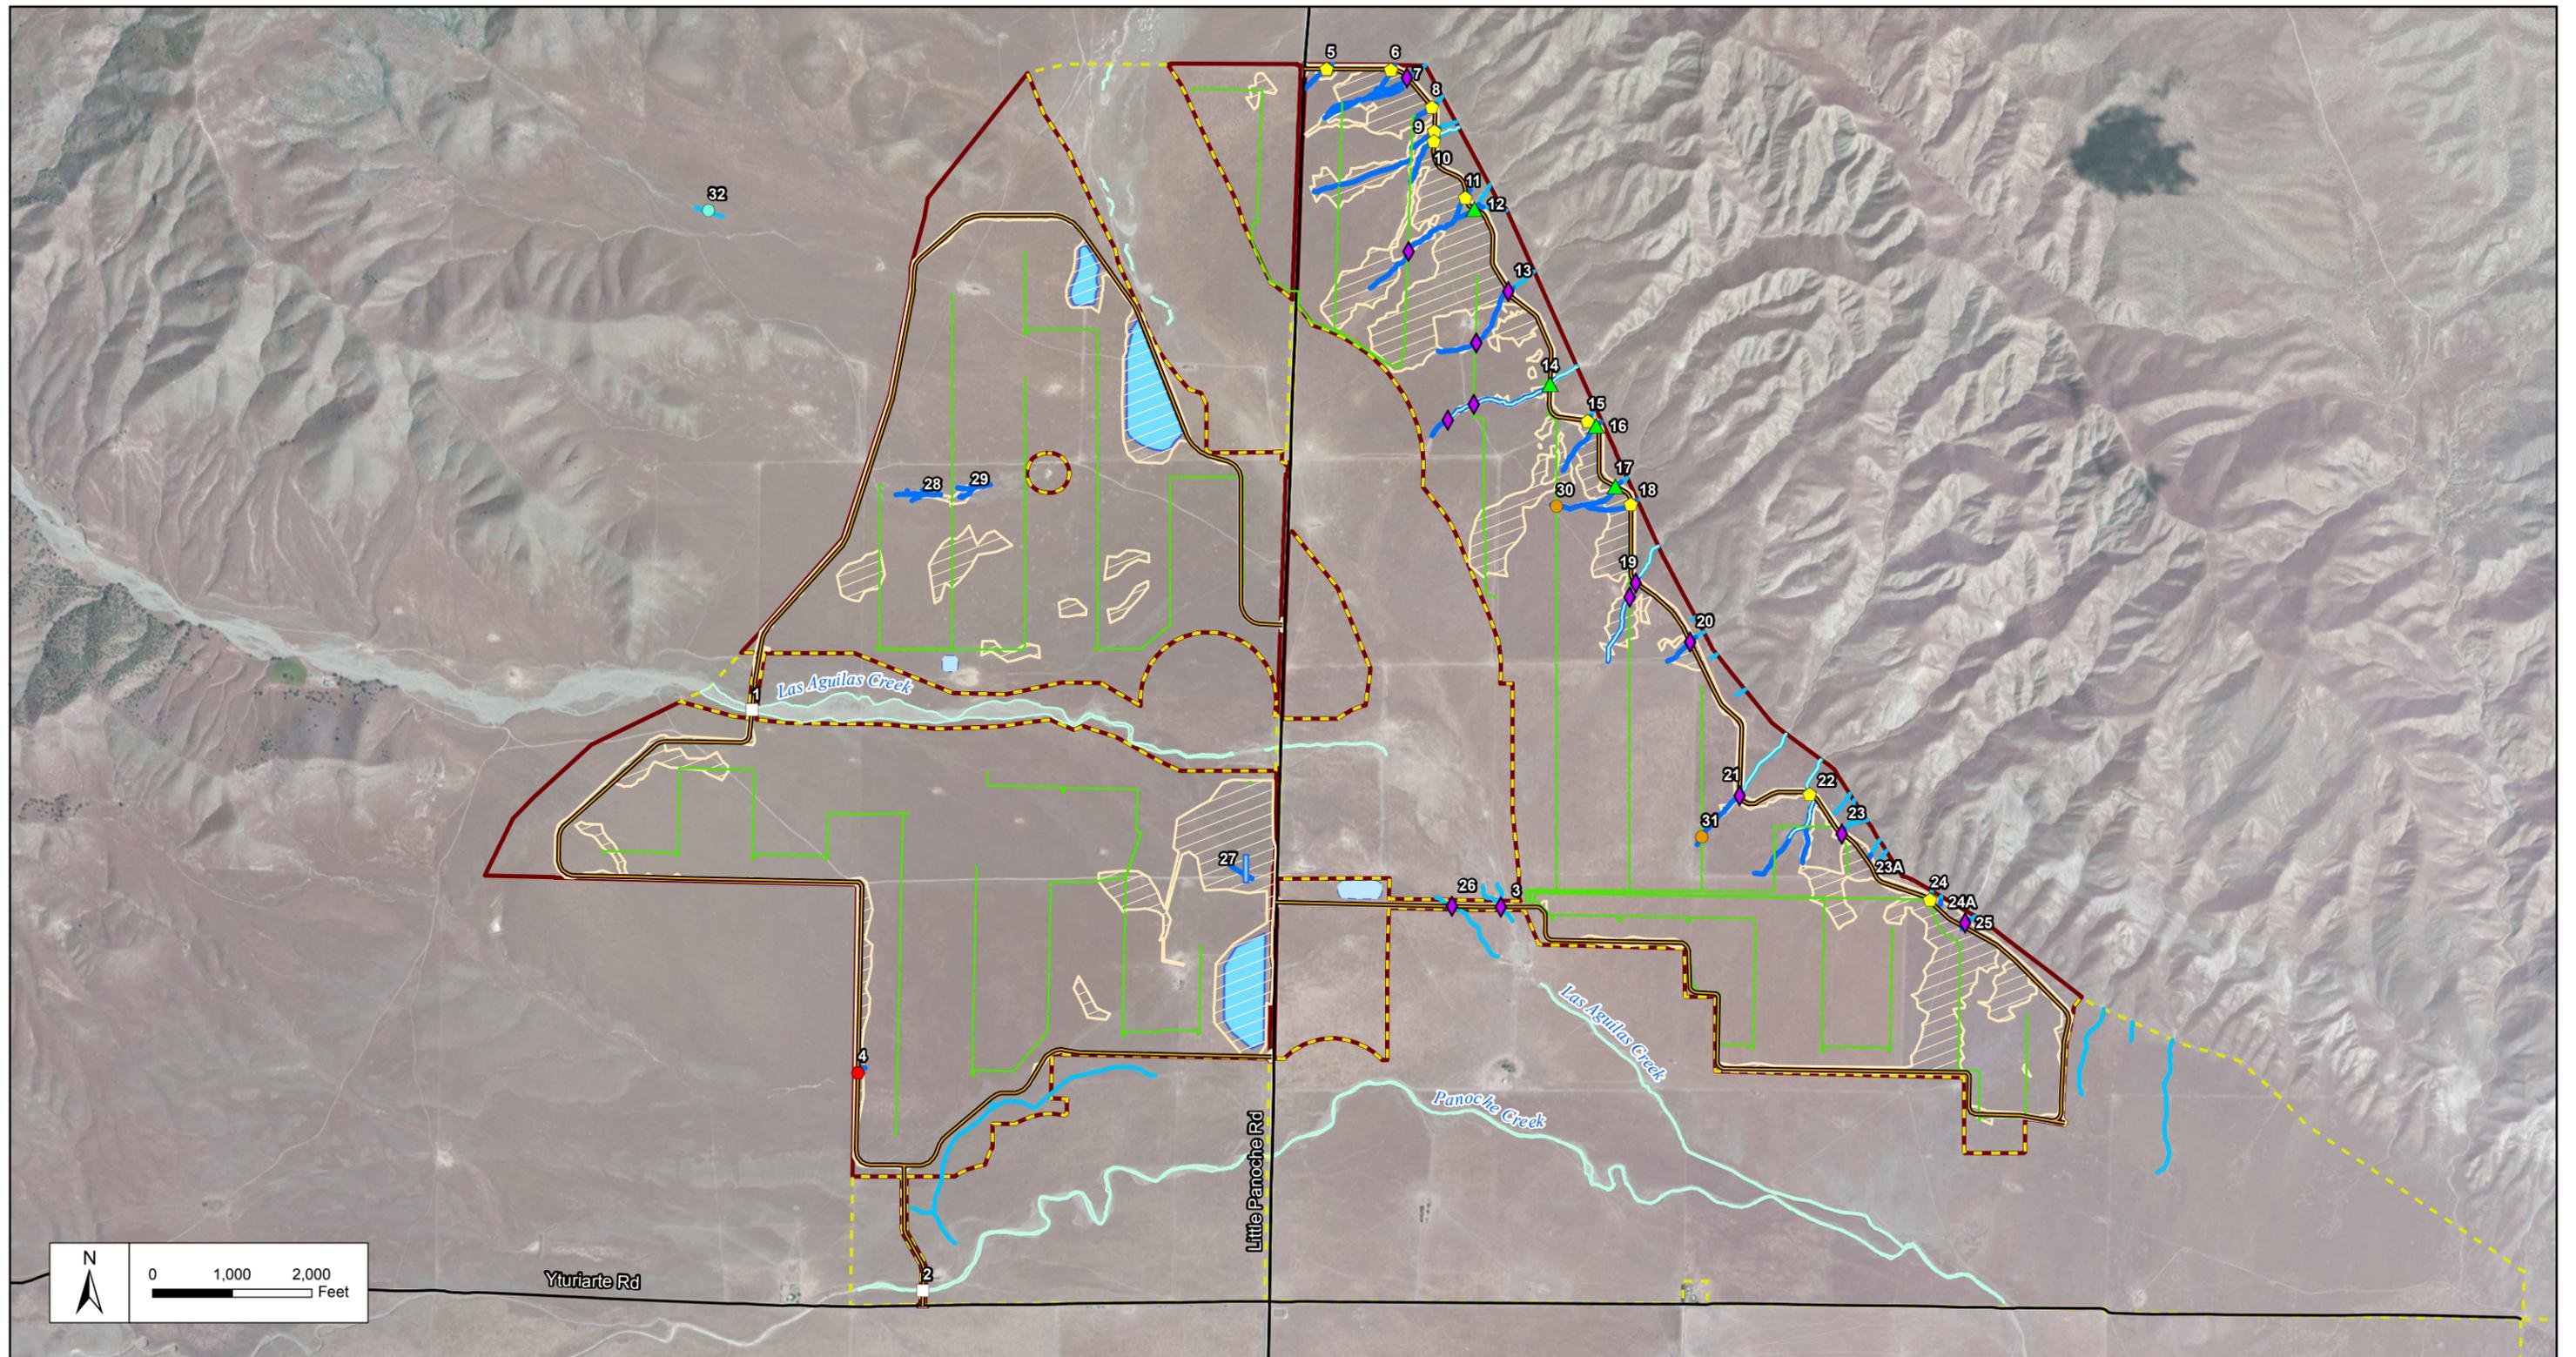
FIGURE

Drainage Impacts

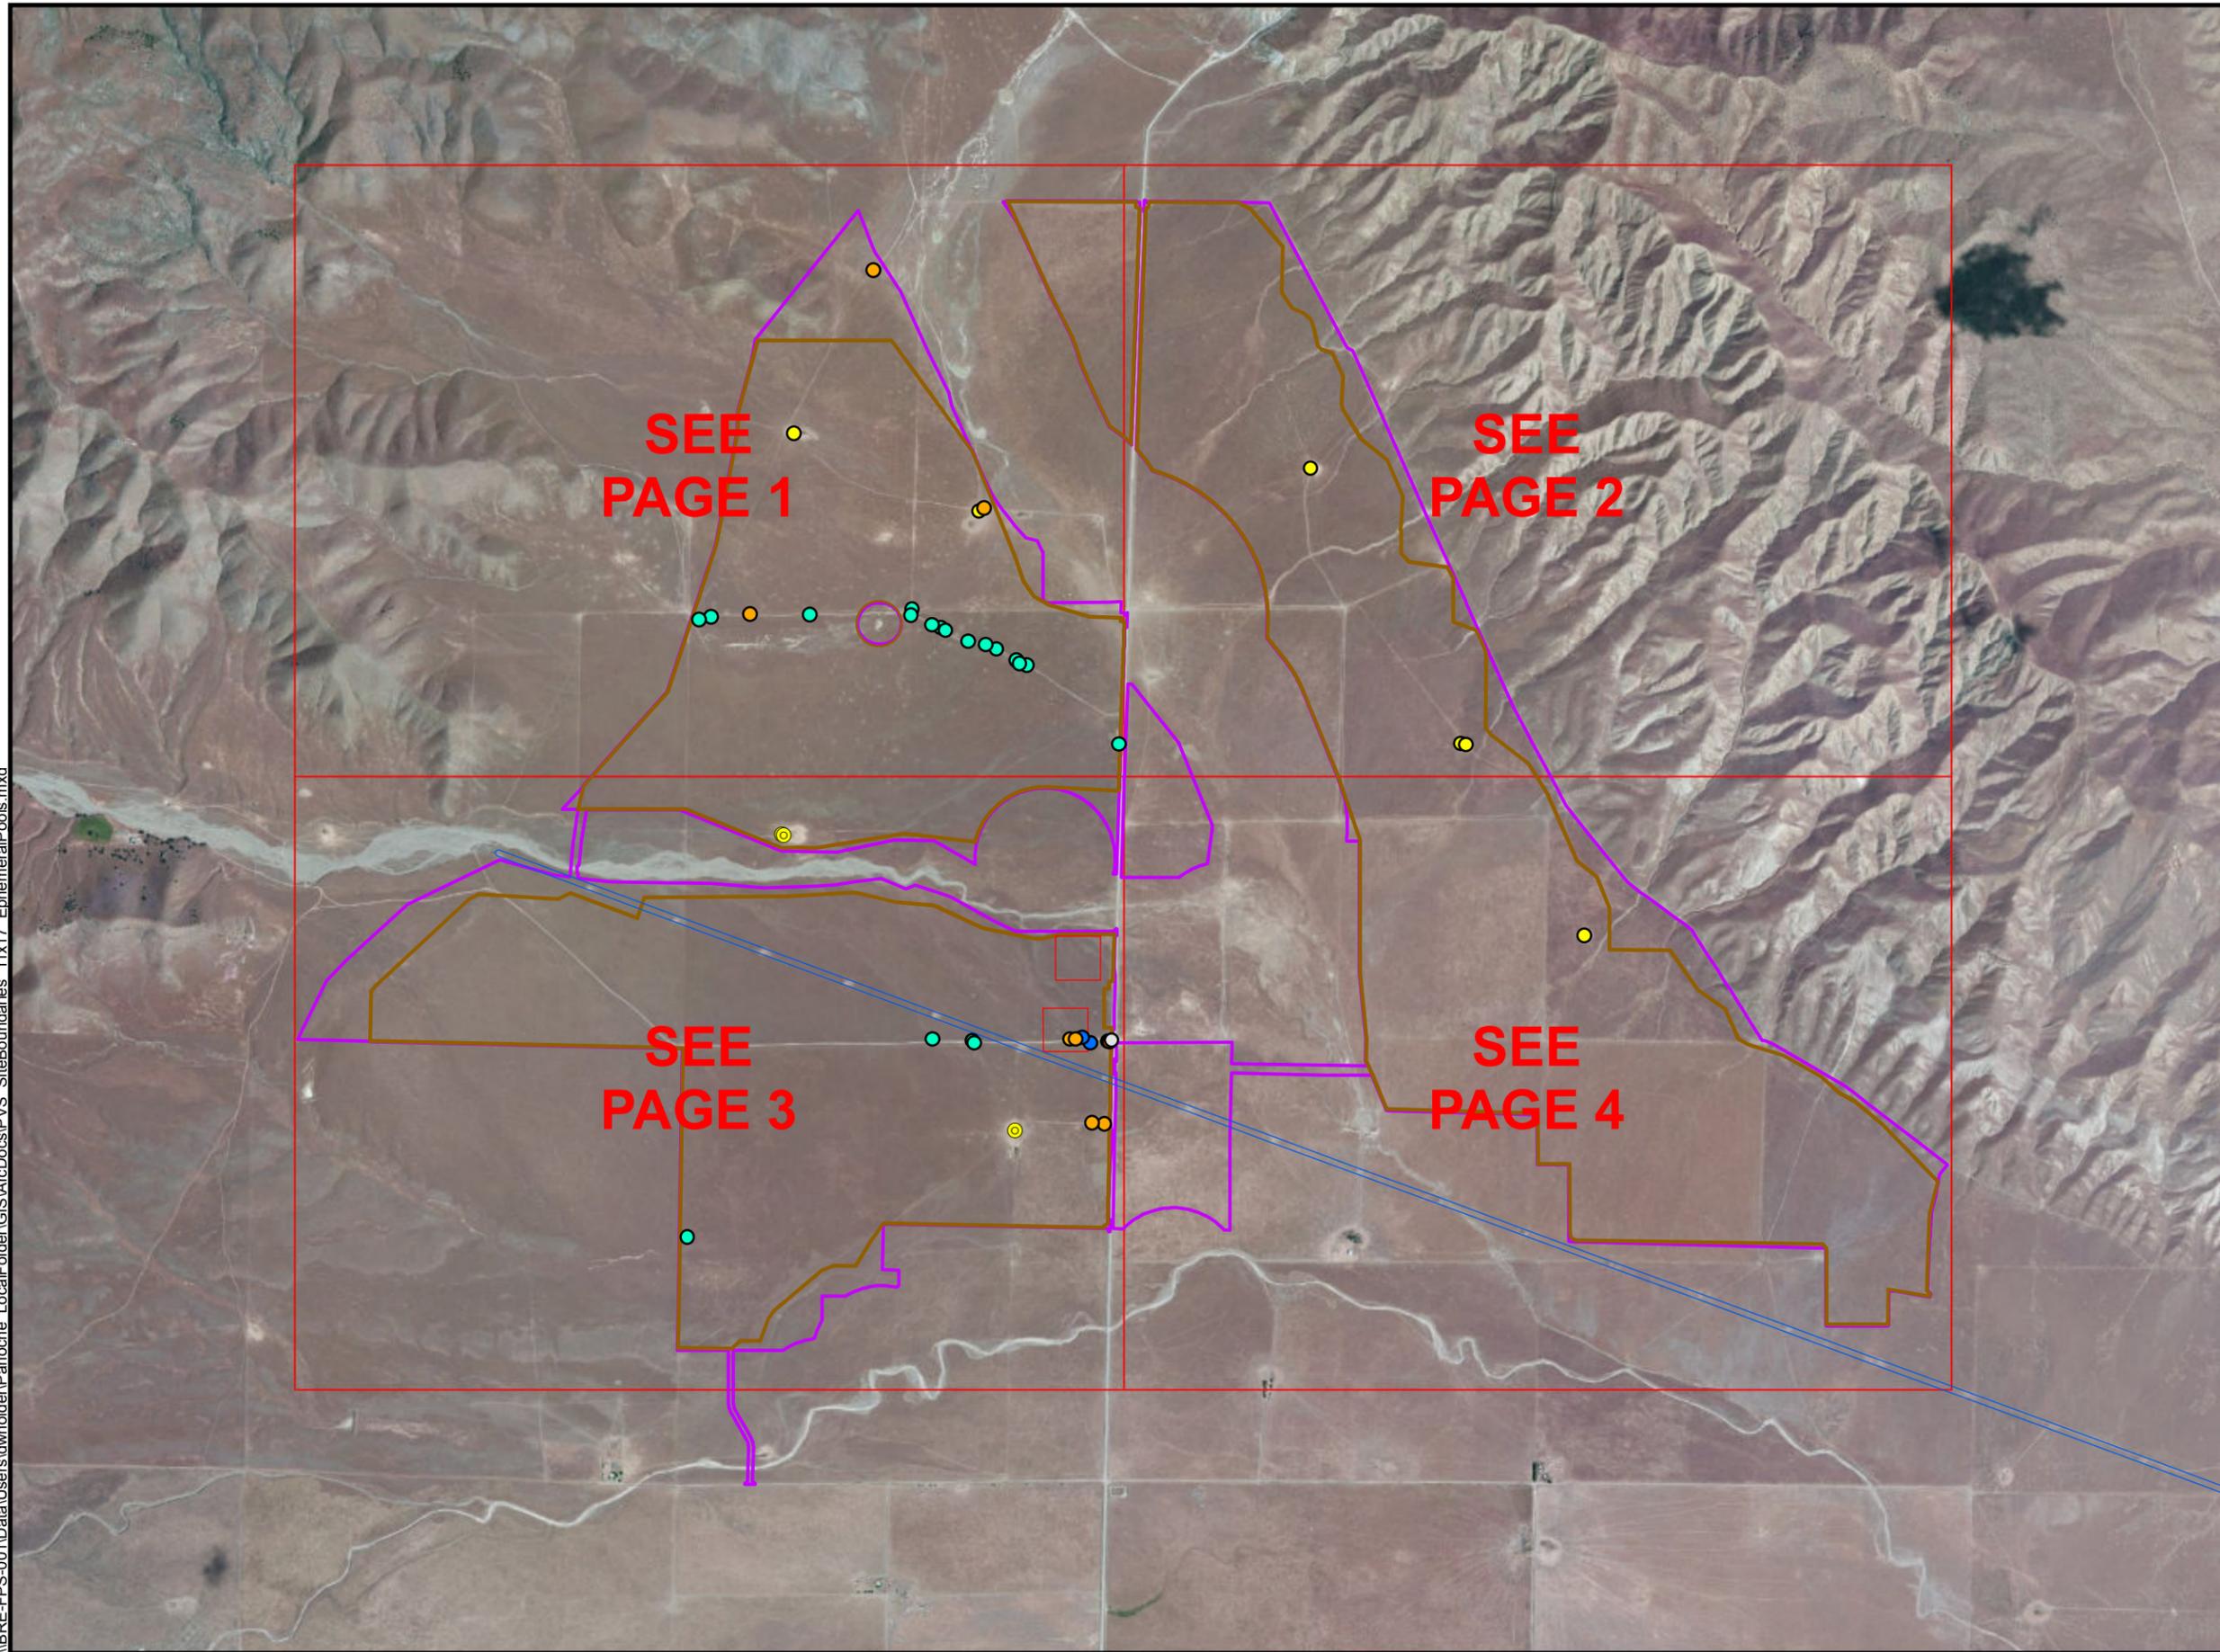
None of the pools were inundated at the time of the evaluation. Of the 40 pool locations evaluated, two were determined to represent possible vernal pools (5 and 36) (Table 1, Figure 2). It should be noted that Pools 5 and 36 appeared to be connected hydrologically but were separated by an unpaved road. Based on dominance by upland plant species, 18 pools were classified as ephemeral pools. These pools were predominantly located adjacent to roads and had evidence of road runoff. Nine of the pools were classified as road puddles. Nine of the previously mapped pools by LOA were not pools, but locations where cattle troughs or tanks had overflowed, resulting in presence of dense upland vegetation. One of the pool locations appeared to be mapped within the Little Panoche right-of-way; however, no evidence of a pool was located (pool 46).

The possible vernal pools that were evaluated (5 and 36) are located near the proposed Las Aguilas switchyard (Figure 1). The impacts to these possible vernal pools have been accounted for in the Lake and Streambed Alteration Agreement (LSAA) submitted to the California Department of Fish and Wildlife (CDFW) in March 2015. The pools in this area have been delineated as a State water drainage and considered as a drainage impact that will be permitted through the project's LSAA with CDFW. The impact planned for this project is due to grading necessary for the proposed construction of the switching station. The grading will impact the State waters drainage in the center portion of the Project Footprint, west of Little Panoche Road. The ground disturbance caused by these planned impacts would result in approximately 5,409 ft² of impact to State waters.
